National Fire Protection Association

Summary Fire Investigation Report Fatal Board and Care Fire September 19, 1990

**Prepared by
Thomas J. Klem
Director, Fire Investigations Department**

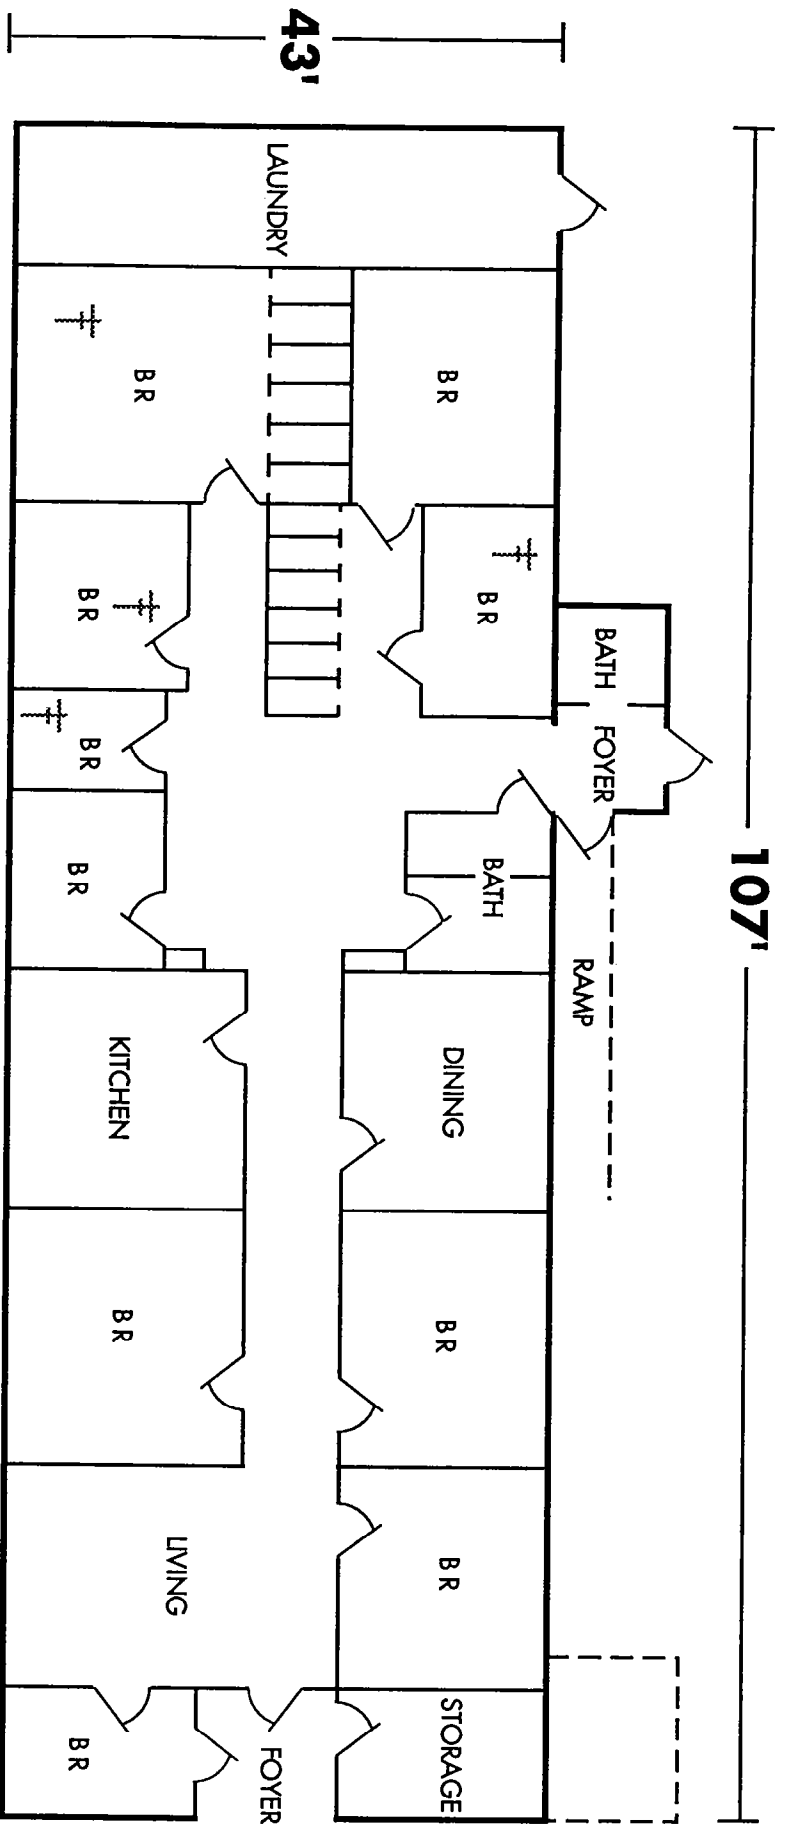
Figure 1: Floor Plan and Fatality Location

The approximately 40-year-old, single-story, wood-frame building was once a single-family residence that was expanded during the 1960s and converted to a nursing home. (See Figure 1) Interior partition and ceiling materials of the building were gypsum material while some walls had multiple layers of wallpaper. The occupancy classification was again changed in more recent years to a board and care facility and licensed by the Alabama Department of Public Health.

The building exits were arranged with a front, main entrance leading to a day room and onto a double loaded exit corridor. The corridor provided access to residents' rooms and to dining and kitchen facilities. The corridor then led to a second day room and the remaining sleeping areas. The second exit for the facility was from this centrally located day room. In slow and impractical facilities, NFPA 101 stipulates that the primary means of escape for each sleeping room shall not be exposed to common living spaces such as living rooms and kitchens. Residents of this facility were required to pass such a common space in exiting the building, which is significant considering the location of the fatalities of this fire.

Within four minutes of the 2:24 a.m. alarm, the first Bessemer fire company arrived on the scene and reported the fire had extended throughout the structure. Fire fighters began fire fighting and rescue operations. Because of the structure's high bedroom windows, the four remaining occupants were removed over ground ladders to the exterior. Despite the rescue efforts, four occupants perished as a result of the fire. The fatalities were all located in rooms between the central day room and the second means of egress; individual room doors were found in the open position.

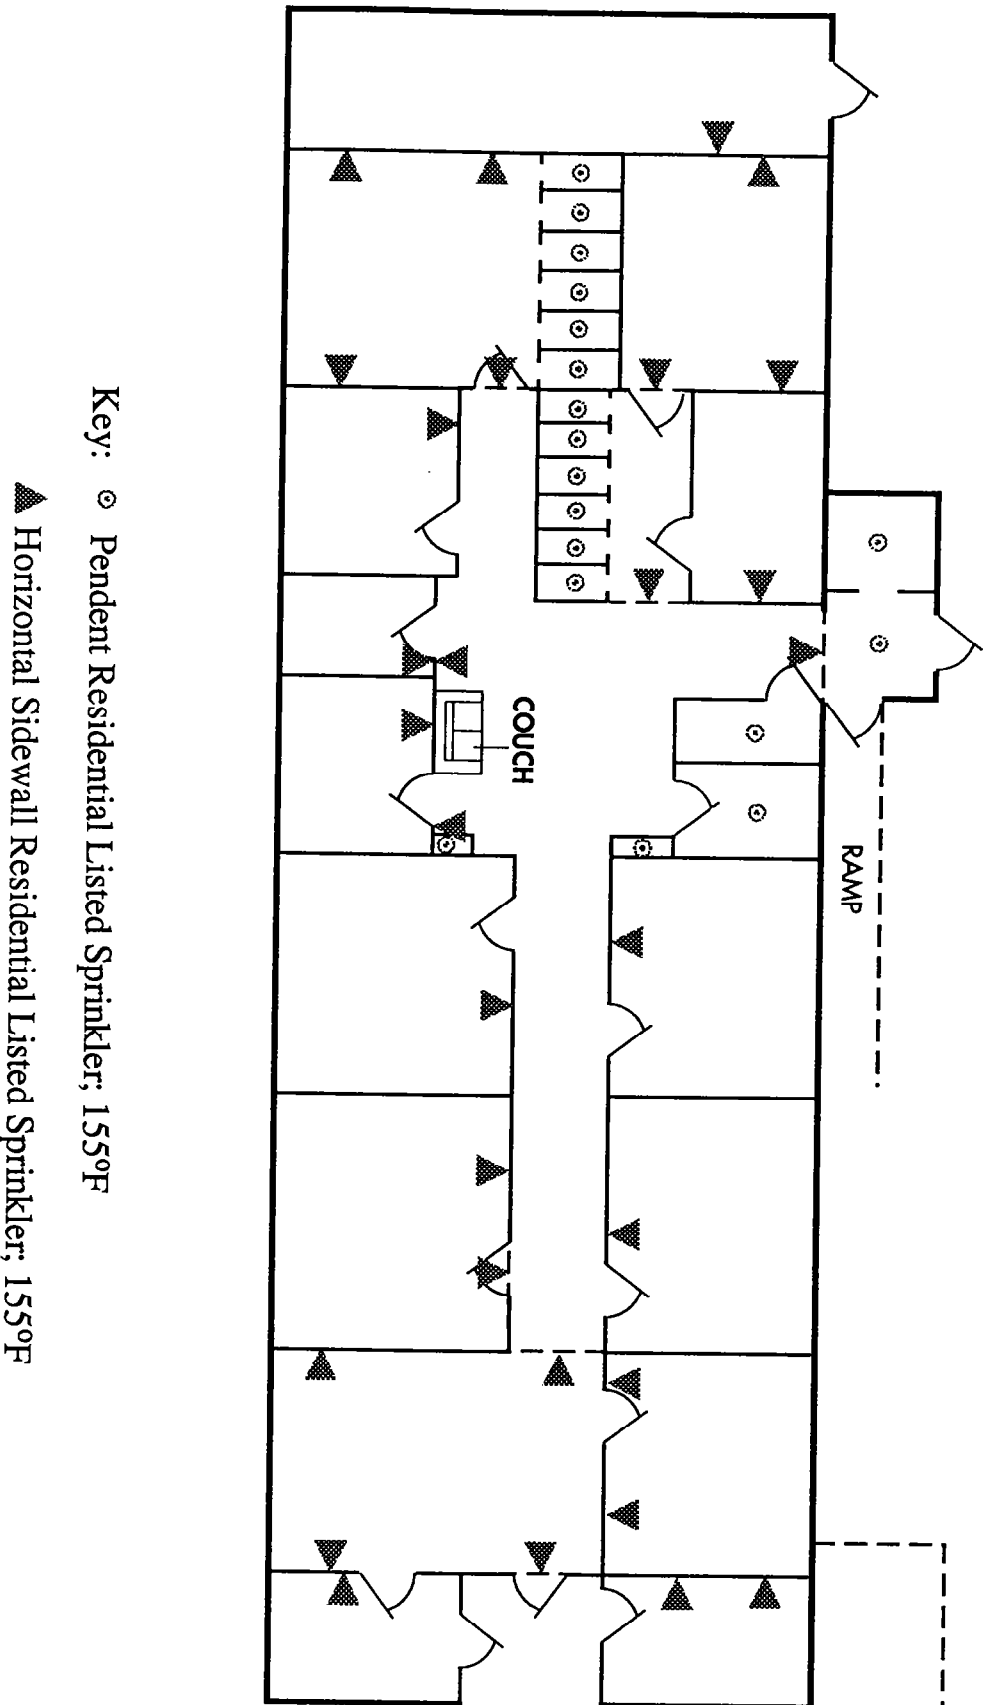
Figure 2: Sprinkler Locations

system through a 1/2-inch galvanized steel water line approximately 40 ft in length, which was then attached within the basement crawl space, to a 1 1/2-inch CPVC (chlorinated polyvinyl chloride) plastic listed supply pipe and on to the sprinkler system riser. The remainder of the system was supplied with exposed, listed CPVC piping mostly installed in accordance with Underwriters Laboratories' listing criteria. It appears that the sprinkler system design was intended to conform to NFPA 13D. In addition, the design appeared to comply with the additional coverage requirements of NFPA 101, mentioned earlier. (See Figure 2) However, the system did not meet the supervisory requirements of paragraph 7-7.2.

Sprinkler plans prepared by a contractor indicate that the system was designed as a double loop system, consisting of mostly 1-inch diameter CPVC pipe with some dead-end lines of 3/4-inch CPVC. The first sprinklers to open in the vicinity of the origin of the fire were listed residential sidewall sprinklers of the frangible bulb type. These sprinklers have a nominal operating temperature of 155° F and a Response Time Index of about 68 (ft^{1/2}, s^{1/2}). System components also included listed residential pendent-type sprinklers. However, they were not considered in this analysis.

Investigators from the Bessemer Fire Department and the State Fire Marshal's Office concluded that the recently installed residential sprinkler system did not operate properly due to an inadequate water supply and that the domestic supply was incapable of providing the minimum water supply to even one sprinkler.

Water supply tests conducted after the fire indicate that adequate water supply was available from the municipal system along 19th Street. However, a flow test conducted of the 1/2-inch domestic supply revealed a considerable pressure drop and flow of approximately 5 gpm. Additional flow tests conducted at the riser determined that the supply for the system was 4-5 gpm at 1-2 psi. This inadequate water supply was present despite the high static pressures available to the system of 98 psi, illustrating the importance of understanding the differences between pressure and flow considerations in sprinkler system design, maintenance, and inspection. In addition to this major deficiency, the Bessemer Fire Department found

A principal lesson from this incident is that residential sprinkler systems, as well as other fire protection systems and features must fully comply with all requirements of codes and standards. Sprinkler listing criteria must be closely examined to ensure compliance with the system's design. Further, we must not be deceived into thinking that adequate water supply is available because static water pressures are high. A flow test of the domestic supply to the building in this fire would have revealed this fact. Finally, building and fire officials must examine the approval, inspection, and licensing process for residential and other sprinkler installations to help ensure code compliance and life safety.
