**ELDERLY HOUSING FIRE**

Johnson City, TN

December 24, 1989

## **FIRE INVESTIGATION REPORT**

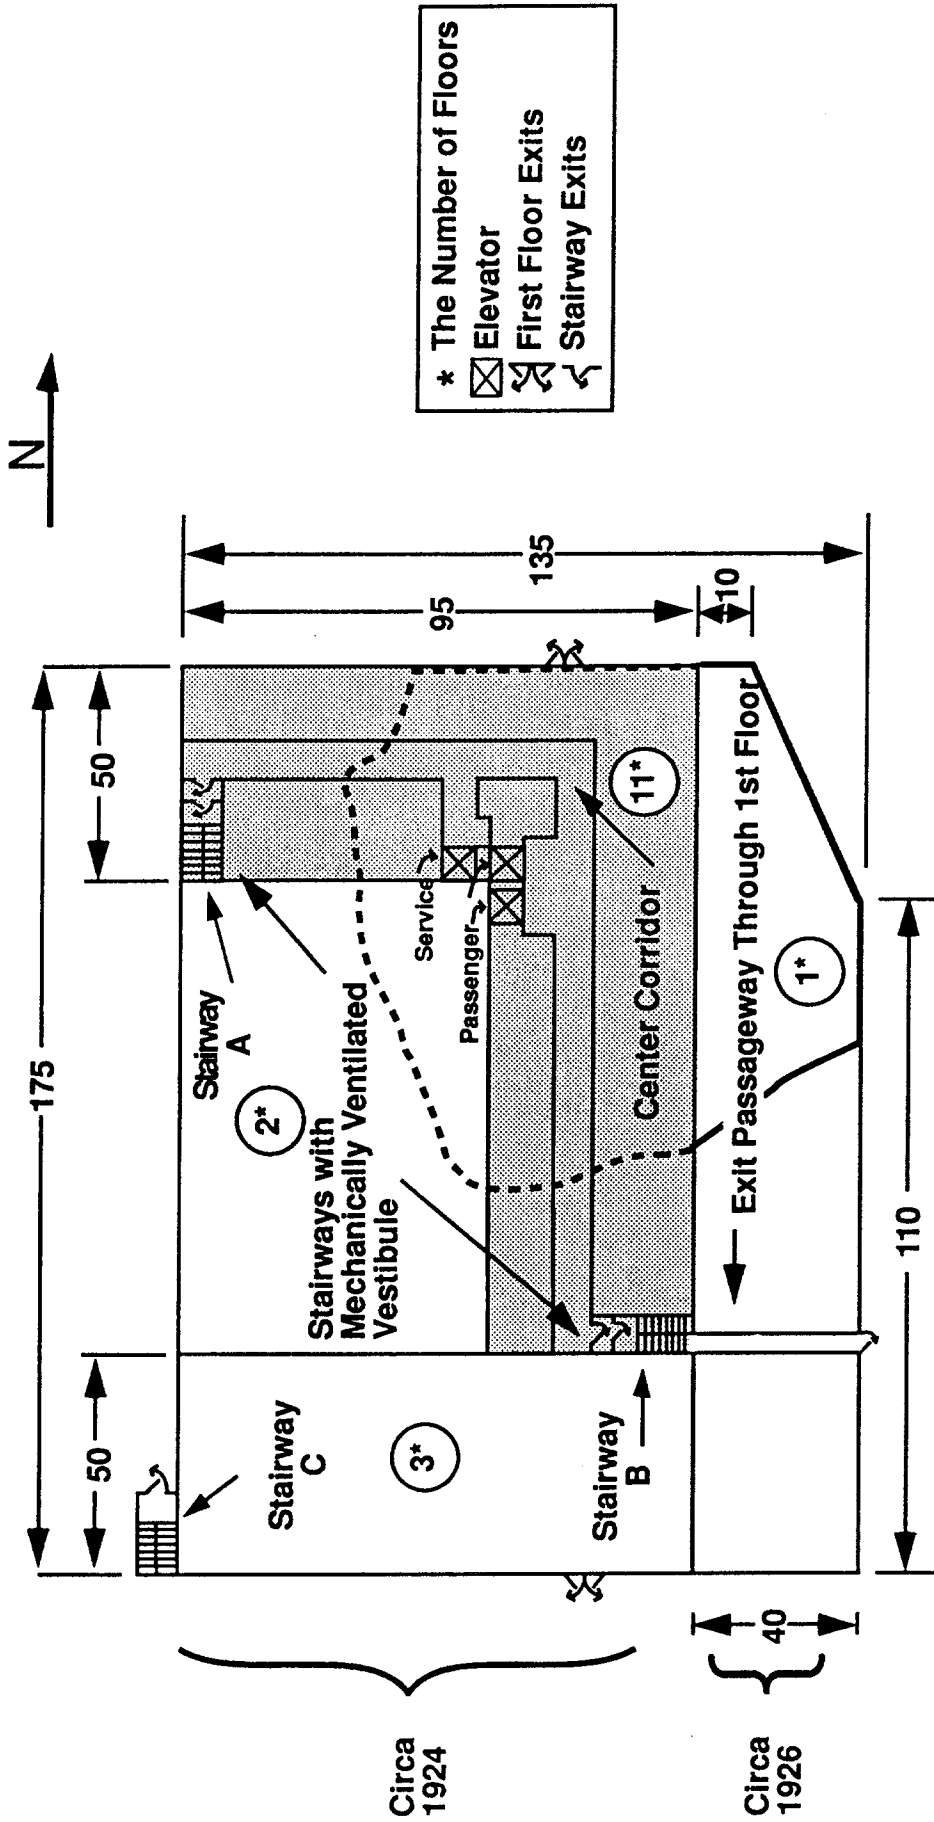
**Figure 1: Building Plan and Exit Arrangement**

First floor occupants normally exited through a center lobby area that had two grade-level exits; one was on the north side of the building and the other was on the south side. (See Figure 1.) In addition to these exits, they could also enter Stairway A and exit the building through that means. The occupants of the second and third floors had access to Stairways A and B, and they also had access to a third stairway, Stairway C, at the southwest corner of the building. This stairway discharged directly to the building's exterior.

Stairways A and B were constructed during the 1977 renovations and were located at the opposite ends of a central corridor on Floors 4 through 10. These stairways discharged directly to the outside of the building and were equipped with mechanically ventilated vestibules. Each vestibule had a forced supply air system using ducts and a fan that would supply air into each vestibule at a rate of 250 cubic ft. per minute (CFM). The vestibules

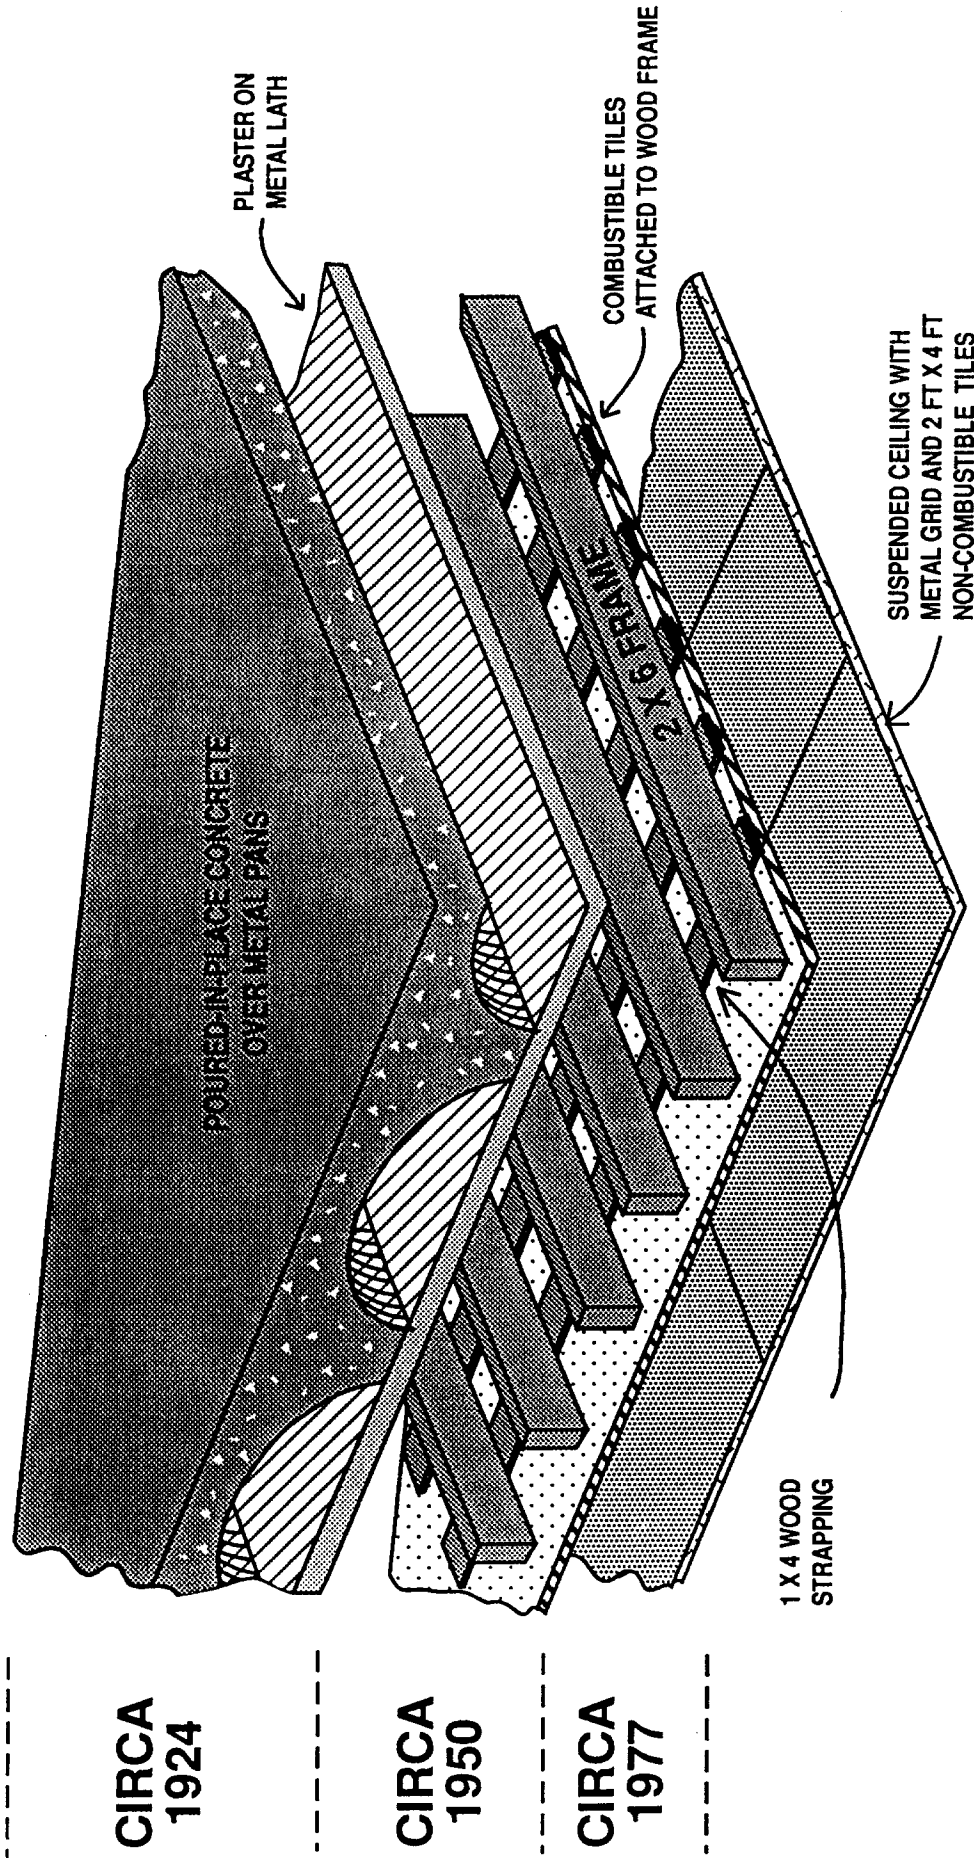
**Figure 2: Floor/Ceiling Assemblies**

In the 1950s, the building was renovated because its original use as a hotel declined through the years. During this renovation, portions of the first three floors were renovated, but the original fire-resistive construction was not duplicated. For example, unprotected steel beams and poured-in-place concrete slabs were used to construct a new second floor at the original mezzanine level for the hotel lobby. In addition, a new, lower ceiling was also installed during the 1950's renovation. This ceiling was about one foot below the original plaster ceiling and had a 2 ft. X 6 ft. wood frame (See Figure 2). Wood strips were attached to the frame, and combustible ceiling tiles were then stapled to the strips.

The newest interior partitions extended up to a new ceiling assembly that was also constructed during this renovation. This ceiling was a nonfire-rated, suspended type with noncombustible tiles supported by a grid of metal channels. The ceiling was attached to and approximately 18 in. below the combustible ceiling previously installed; as a result, there were three ceilings above most occupant spaces.

The fire spread into the space above the suspended ceiling for Apartment 102 and ignited the combustible ceiling tiles that were installed during the 1950's renovation and spread into the space above the combustible ceiling assembly. The fire, which was now being fueled by both the combustible tiles and the combustible framework, travelled horizontally over the majority of the first floor because many of the interior partitions did not extend up to the original floor/ceiling assembly constructed in 1924.

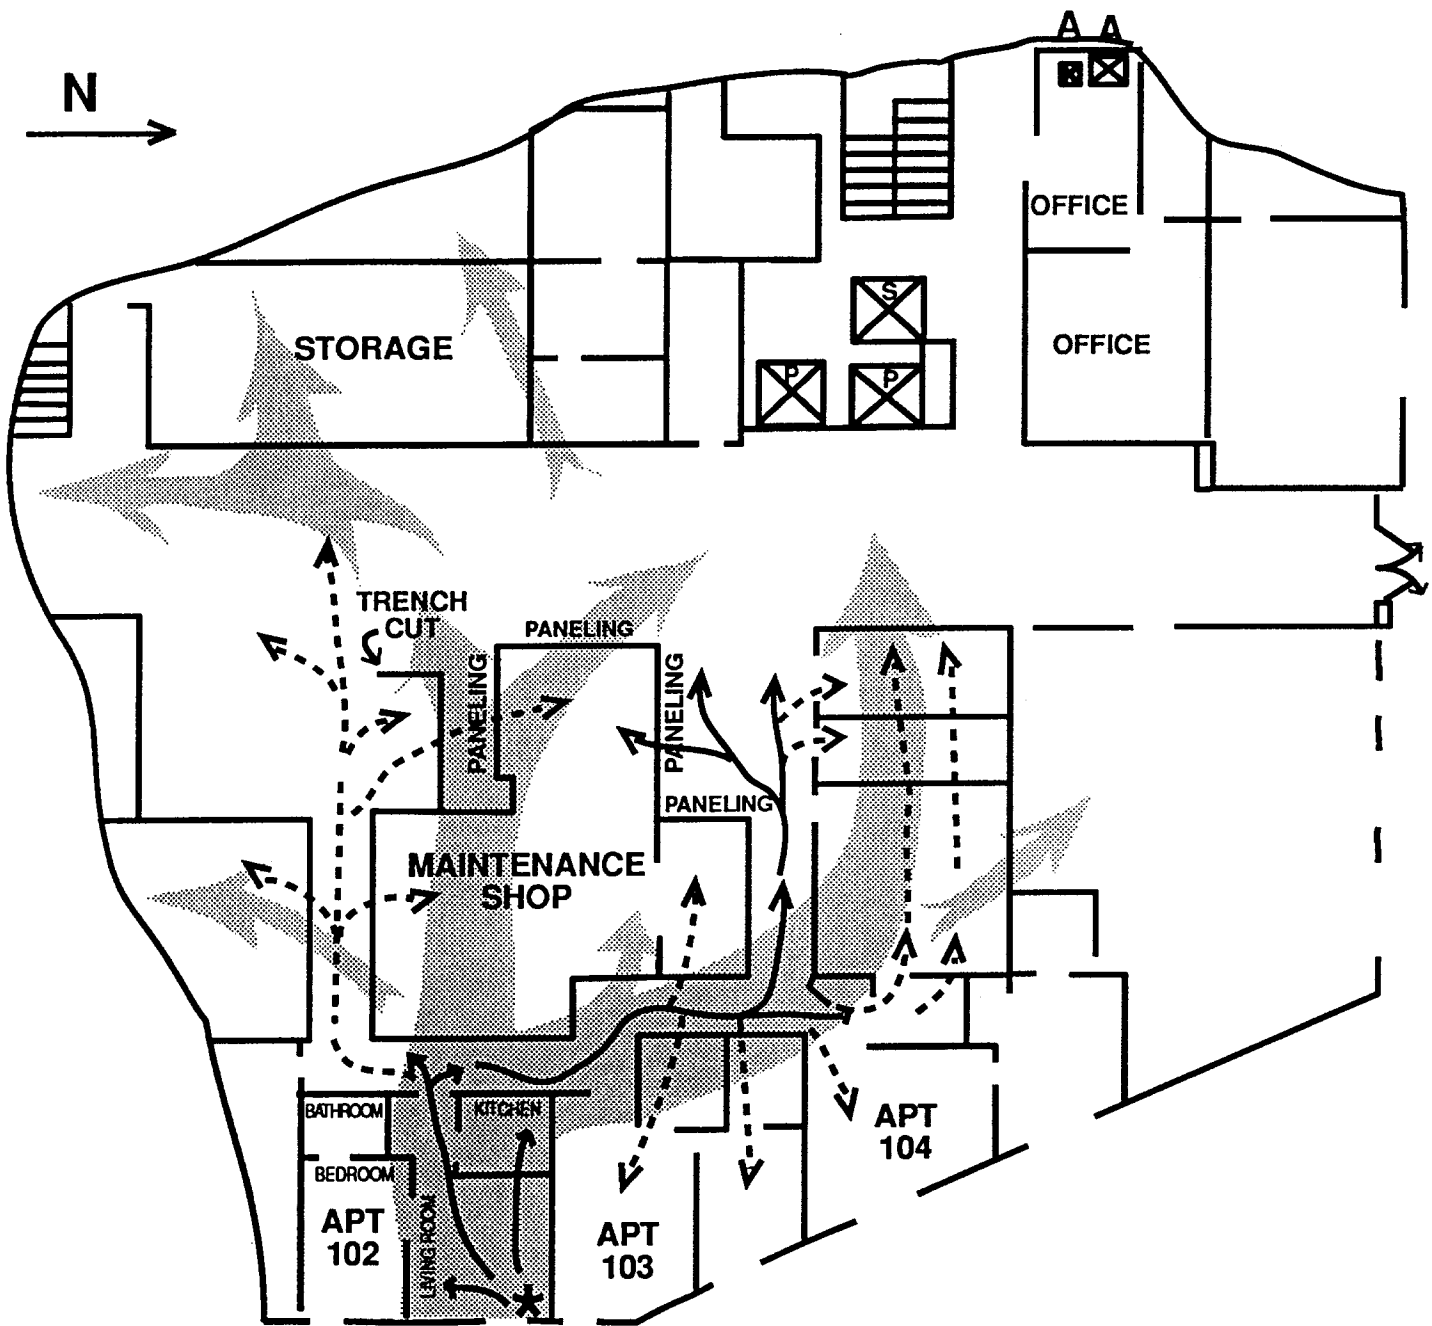
**Figure 3: Area of Fire Origin**

State and local investigators have also concluded that the fire most likely spread from the living room toward the open apartment door and corridor. This finding is supported by the minor fire damage that occurred in the bedroom of Apartment 102. Even though the door between the bedroom and living room was likely open during the fire, and the wall separating these two rooms did not extend up to the combustible ceiling assembly, the most severe fire damage occurred in the living room and kitchen. Since the apartment entrance door was not equipped with a closer and the occupant left that door open when she left the room, the fire in the apartment's kitchen readily spread into the corridor.

Once in the corridor, the primary fire spread appears to have been toward the north past Apartment 103, which had its door closed and past Apartment 104 which had a closed door. The fire continued down the corridor and spread into the public areas that had combustible interior finishes. (See Figure 3.) These combustibles contributed to the fire intensity in the lobby area.

The figure also shows that some fire, i.e., secondary fire spread from Apartment 102, travelled south in the corridor toward the lobby. Other secondary fire spread paths were noted between the suspended ceiling and combustible ceiling assembly. Small holes, duct penetrations, and other voids in the interior partitions allowed the corridor fire to spread into spaces above the ceiling in Apartments 103 and 104, the maintenance shop, and other areas.
